Peak Discharge, Flood Profile, Flood Inundation, and Debris Movement Accompanying the Failure of the Upper Reservoir at the Taum Sauk Pump Storage Facility near Lesterville, Missouri

Scientific Investigations Report 2006–5284

By Paul H. Rydlund, Jr.

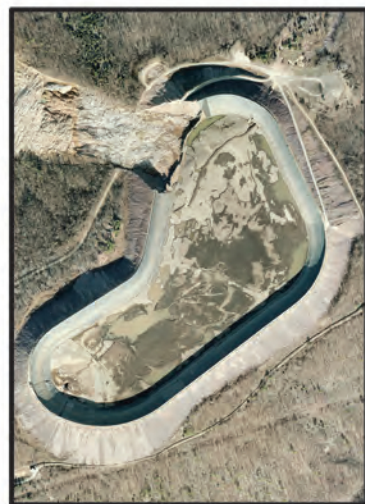
Front Cover. Upper reservoir embankment failure at the Taum Sauk pump storage facility near Lesterville, Missouri, January, 2006 (photograph published with permission from MACTEC Engineering and Consulting, Inc.).

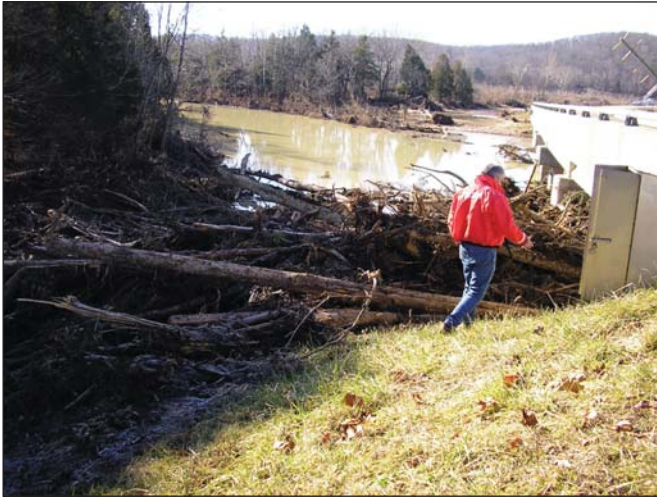
U.S. Geological Survey streamflow-gaging station and debris accumulation.

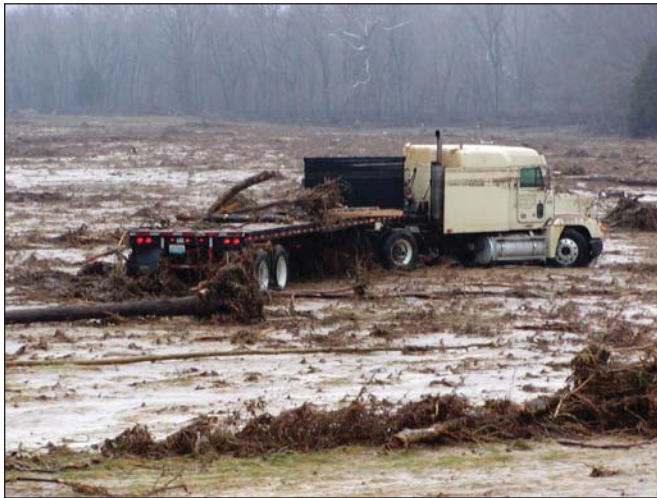
Tractor trailer washed off of State Highway N. Note the high water mark on the cab of the truck (photograph courtesy of Ken Beck, Reynolds County Courier, 2005).

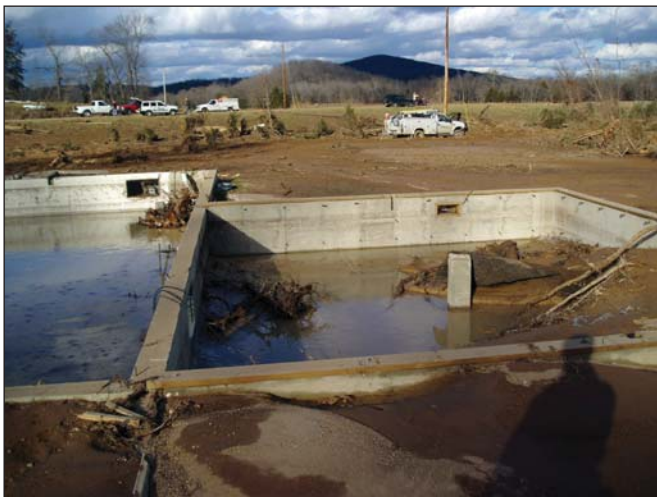
Exposed foundation of park superintendent residence.

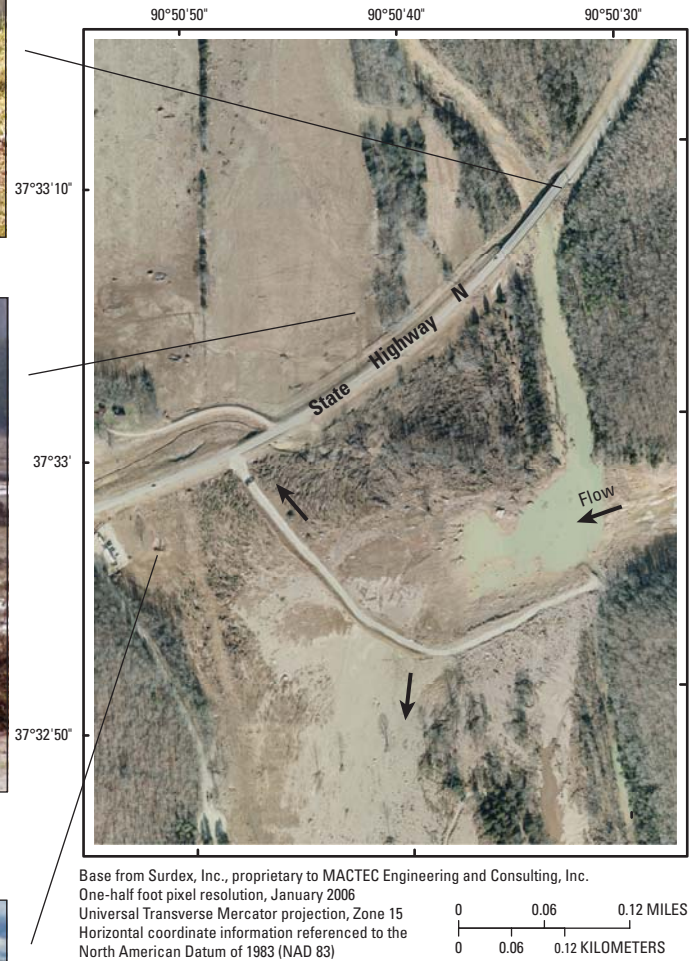
Figure 2. Flood wave damage at base of Proffit Mountain and State Highway N.

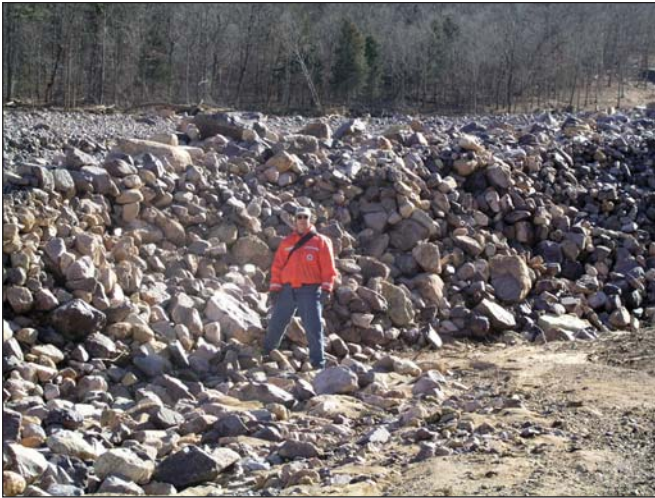
Boulders from upper reservoir embankment structure and interspersed overburden.

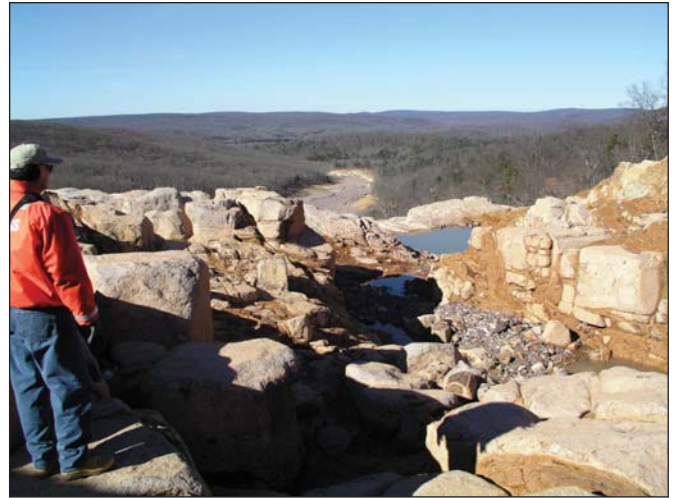
Exposed bedrock downstream from upper reservoir embankment breach.

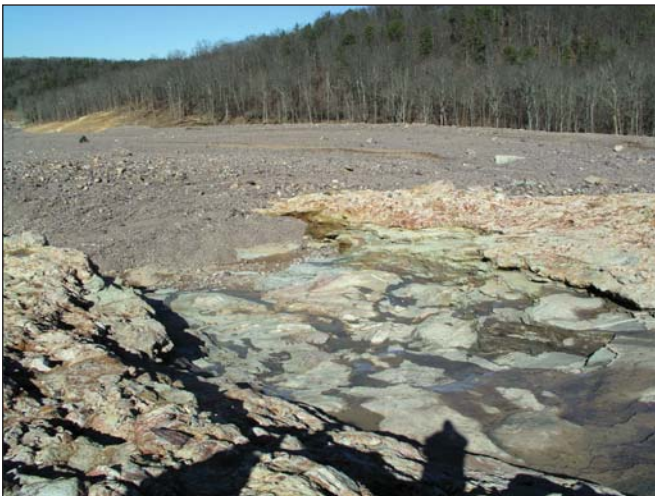
Exposed bedrock and assorted overburden.

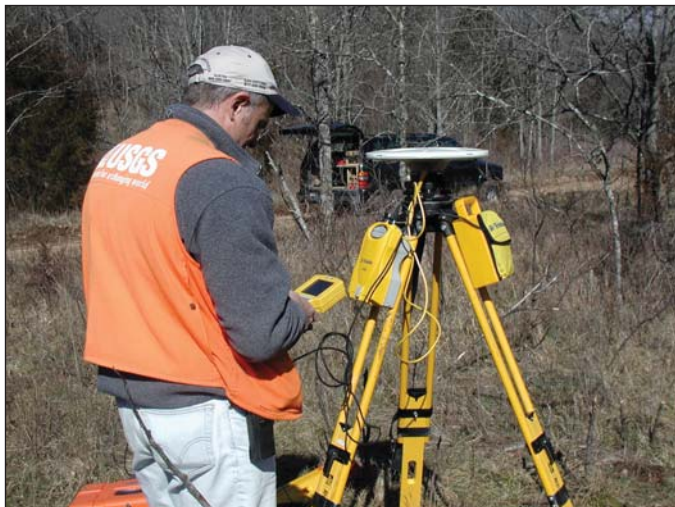
Global Positioning System (GPS) static session surveying.

Figure 5. Topographic survey along Taum Sauk Creek, February 6, 2006.

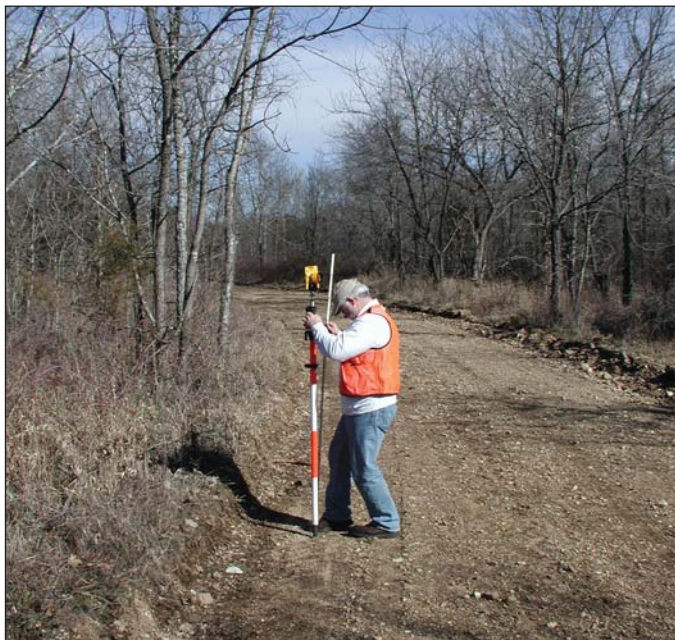
Rod height calibration for total station instrument surveying.

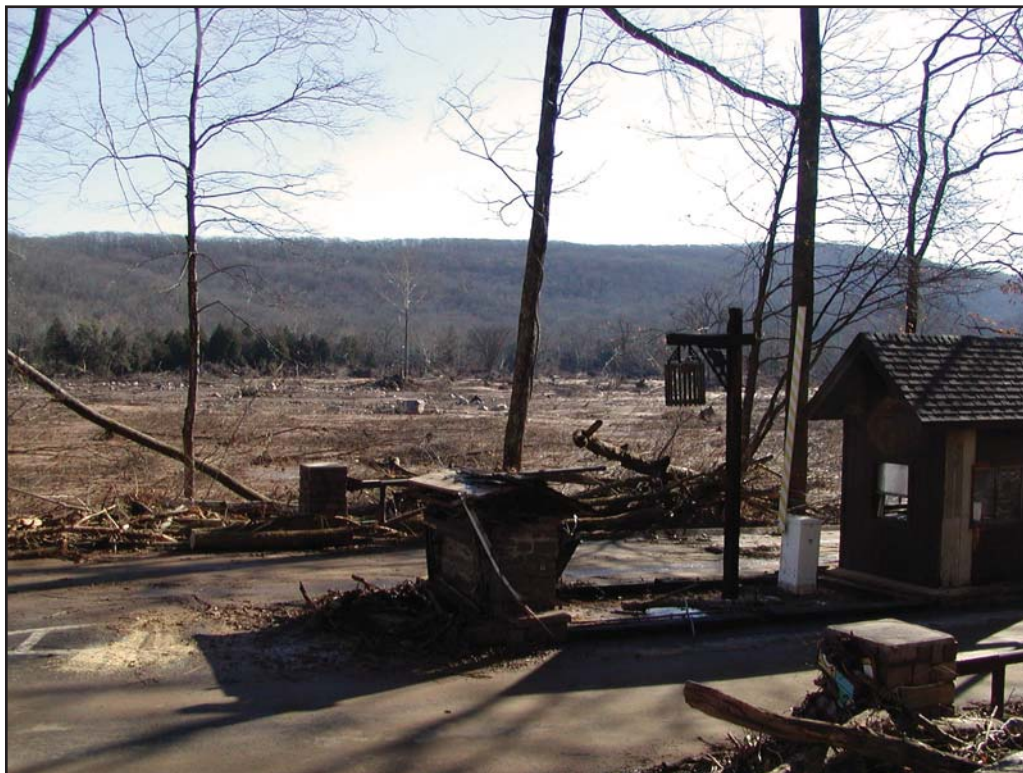
Upper reservoir embankment failure flood damage at the entrance and vicinity of the Johnson's Shut-Ins State Park (photograph courtesy of Ken Beck, Reynolds County Courier, 2005).
